**NIST NCSTAR 1-2B**

**Federal Building and Fire Safety Investigation of the  
World Trade Center Disaster**

**Analysis of Aircraft Impacts into the  
World Trade Center Towers**

September 2005

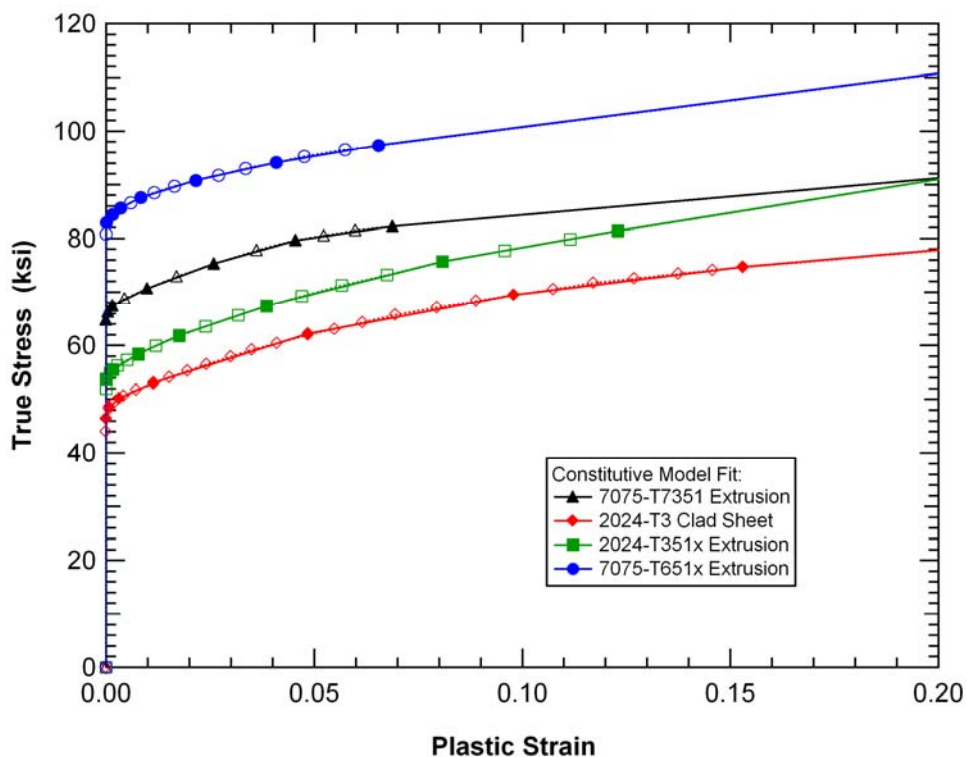
**Figure E-6. True stress-strain curves developed for various aircraft aluminum alloys.**

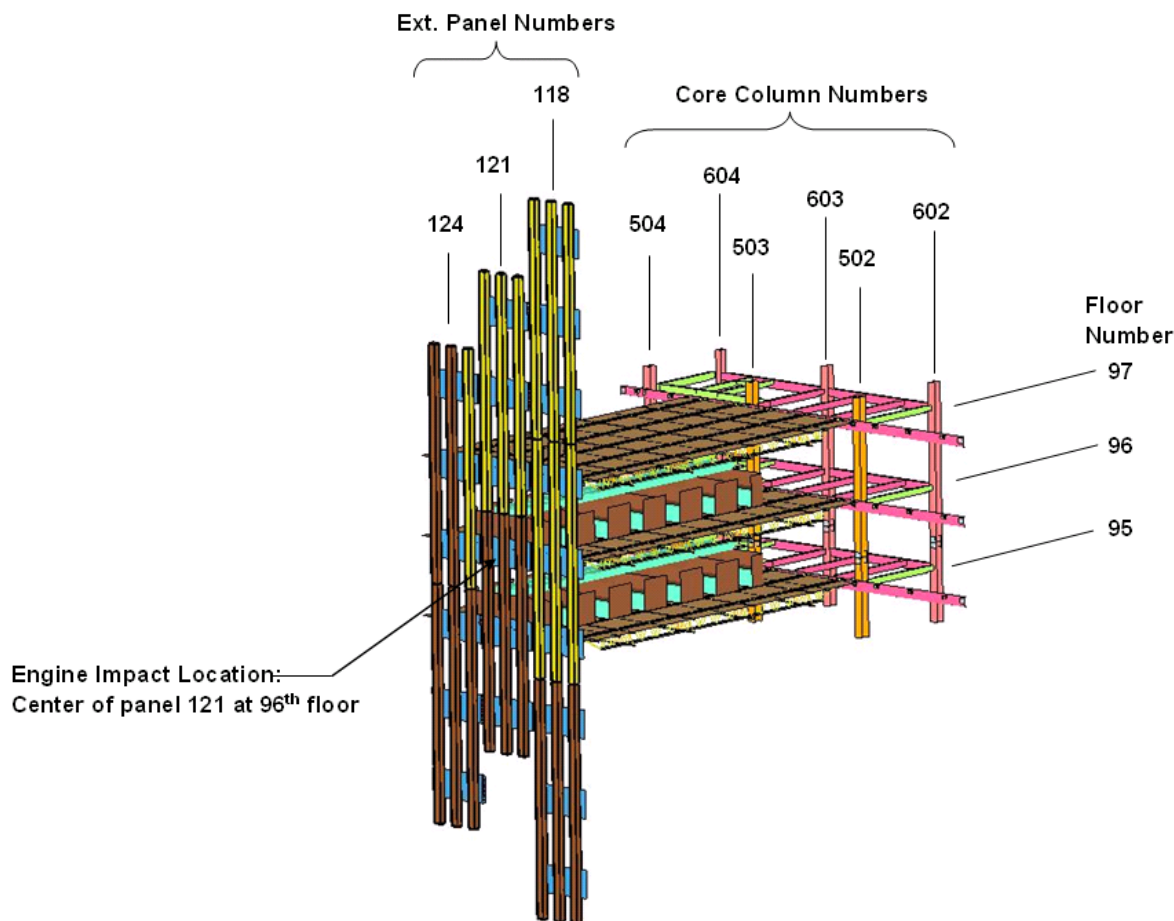
The subassembly analyses were used as a transition between the component level analyses and the global impact analyses. With the subassembly analyses, more complex structural behavior not captured in the component analyses could be investigated with significantly shorter run times than required for the global analyses. The subassembly analyses were primarily used to investigate different modeling techniques and associated model size, run times, numerical stability, and impact response. The final subassembly model used structural components from the impact zone on the north face of WTC 1. The structural components in the final subassembly model included the exterior panels, core framing, truss floor structures, and interior contents (workstations), Figure E-18.

**Figure E-18. Final WTC tower subassembly model.**

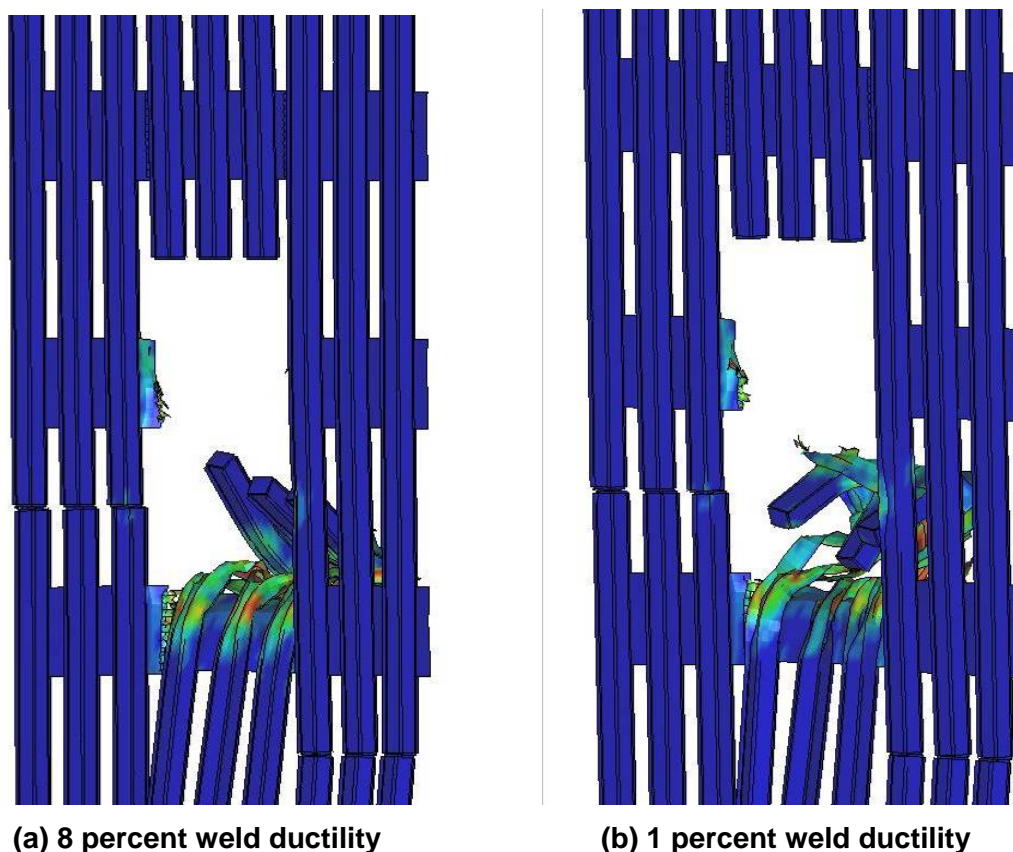
Varying the ductility of the weld zone in the exterior columns from 8 percent to 1 percent did not result in any noticeable difference in the damage pattern (Figure E-21) or the energy absorbed by the exterior panels, indicating that the weld ductility had a negligible effect on the impact response.

**Figure E-21. Exterior wall damage for the wing section impact analyses.**

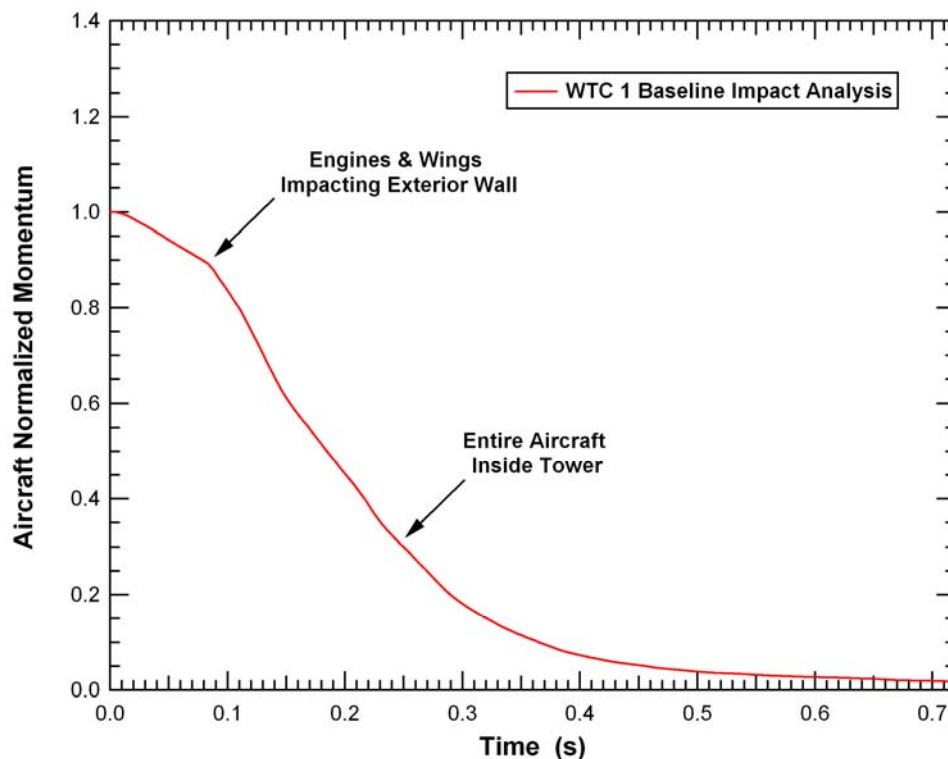
Load transfer of the aircraft momentum into the tower structure is shown in Figure E–27. The momentum plotted was for all of the aircraft structures and contents (including fuel) and was normalized by the initial momentum magnitude. During the first 0.1 s of impact, the forward fuselage penetrated the exterior wall and impacted the interior structures. Between 0.1 s and 0.25 s a more rapid load transfer rate was observed as the area of the impact was larger (extending outward in the wing impact regions) and a higher percentage of the aircraft mass was impacting the interior structures. At 0.25 s, as indicated in Figure E–27, the aircraft completely penetrated the building and retained approximately 30 percent of its initial momentum. Beyond this time, the rate of load transfer steadily decreased with very little load transfer after approximately 0.5 s.

**Figure E-27. Normalized aircraft momentum for the WTC 1 base case impact.**

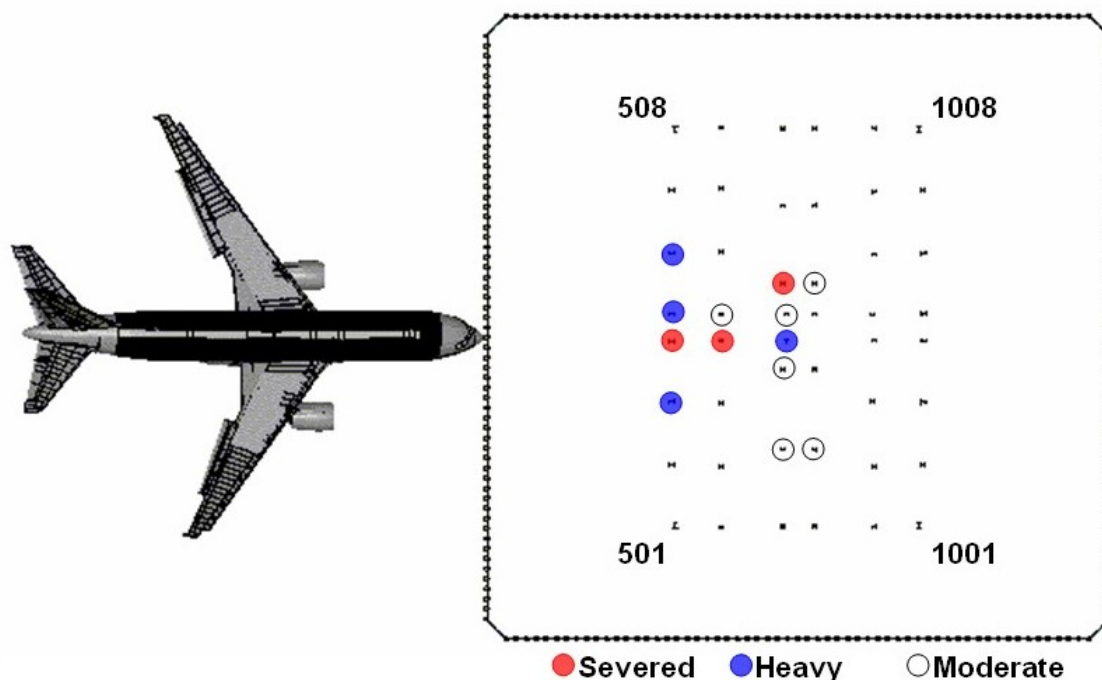
**Figure E-31. Core column damage for the base case WTC 1 impact.**

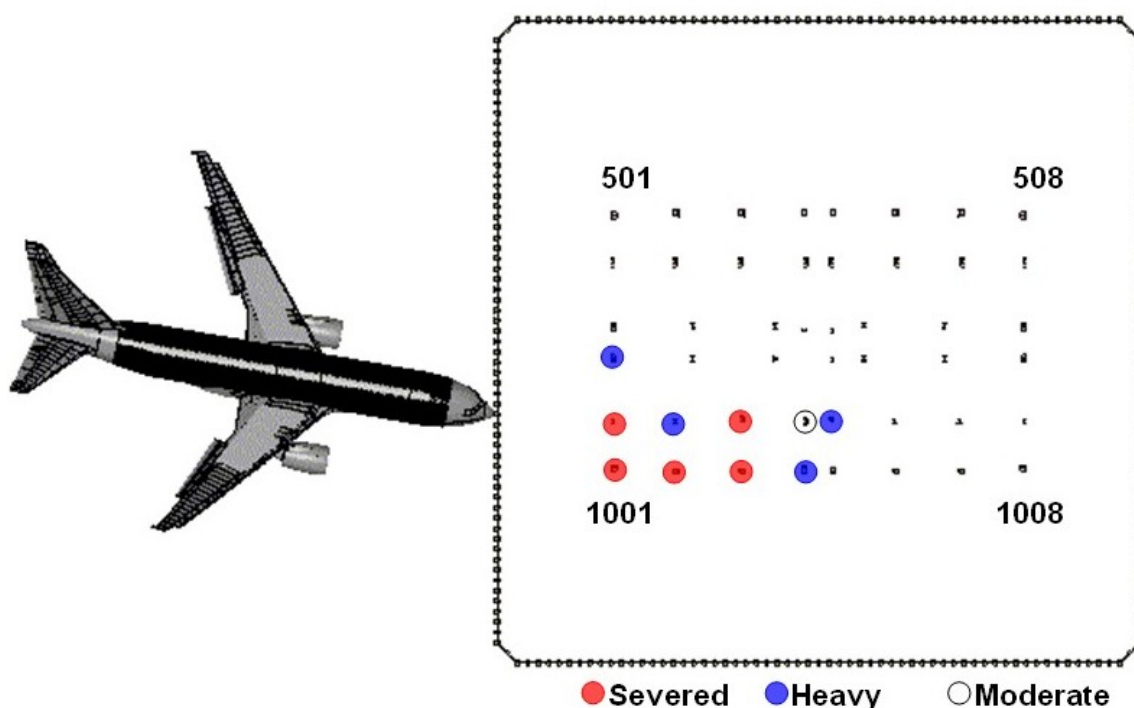
In the base case WTC 2 impact damage analysis, significant damage to the core was calculated in the region close to the impact point (the south east corner of the core). The columns in line with the aircraft fuselage failed on the impact side of the tower and several of the core beams were also severely damaged or failed in the impact zone. In some cases, failure of the column splices located on floors 77, 80, and 83 contributed significantly to the failure of the core columns. This was particularly true for the heavy column number 1001 at the southeast corner of the core that failed at three splice locations. A summary of the column damage is shown graphically in Figure E-39. A total of five columns were severed and four columns were heavily damaged.

Figure E-39. Summary of core column damage for the base case WTC 2 impact.

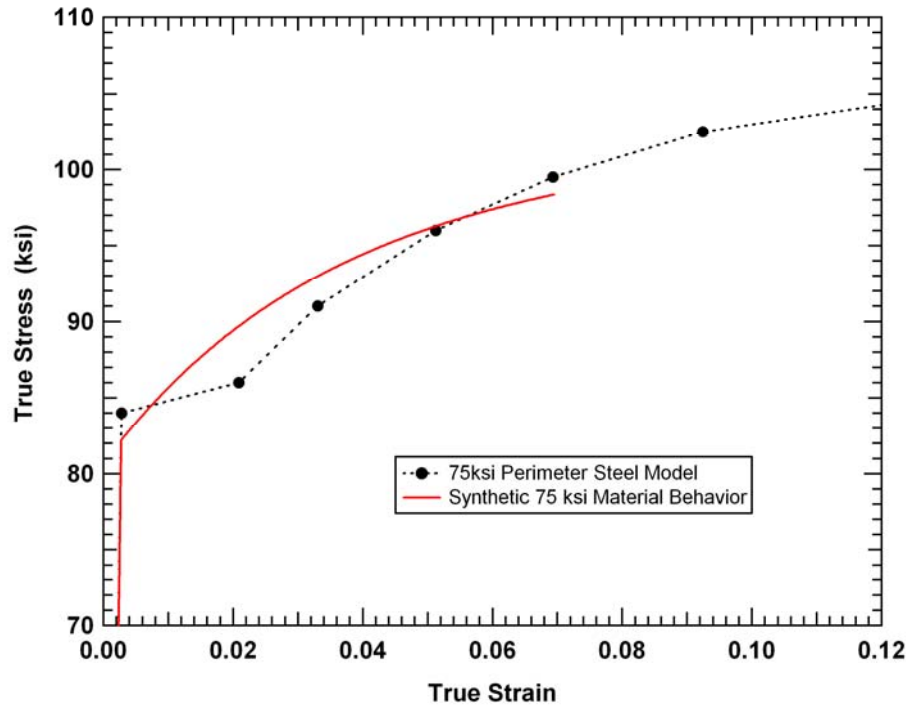
test data were used as the input for the material modeling to provide validated stress-strain properties up to failure. A comparison of this synthetic curve with the constitutive model behavior for the 75 ksi steel is shown in Figure 2–7. There were observable differences in the curves, such as the representation of a yield point behavior in the constitutive model. However, the differences were not sufficiently large to produce a large variation in the calculated structural impact behavior. In addition, the effect of material strength variation on impact damage was assessed in the uncertainty analyses.

**Figure 2–7. Comparison of the constitutive model and synthetic steel behaviors for the 75 ksi steel.**

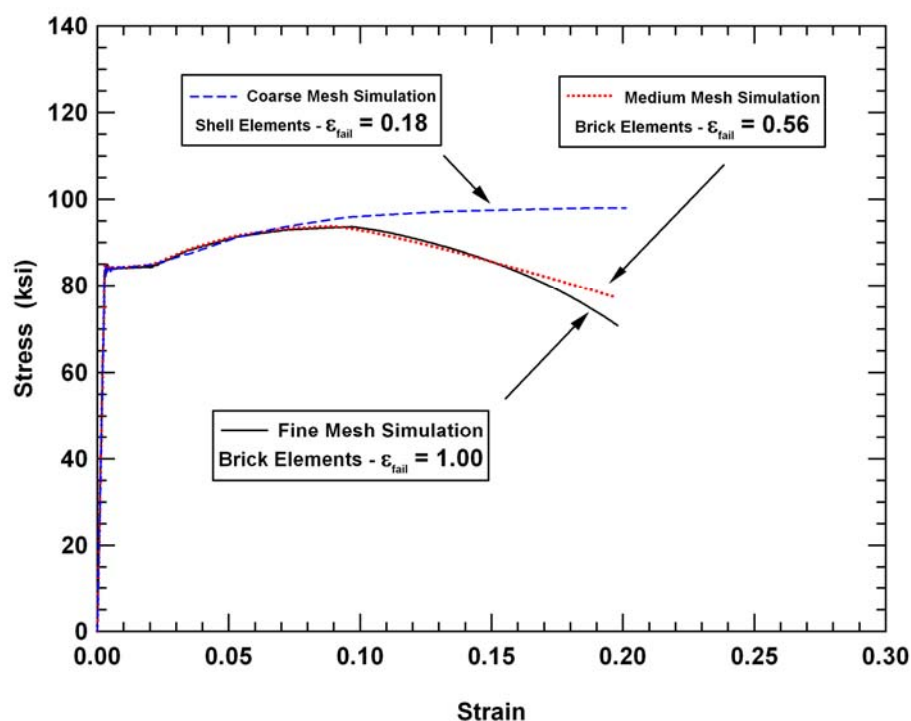
Figure 2-15. Mesh refinement effects in the calculated 75 ksi tensile test.

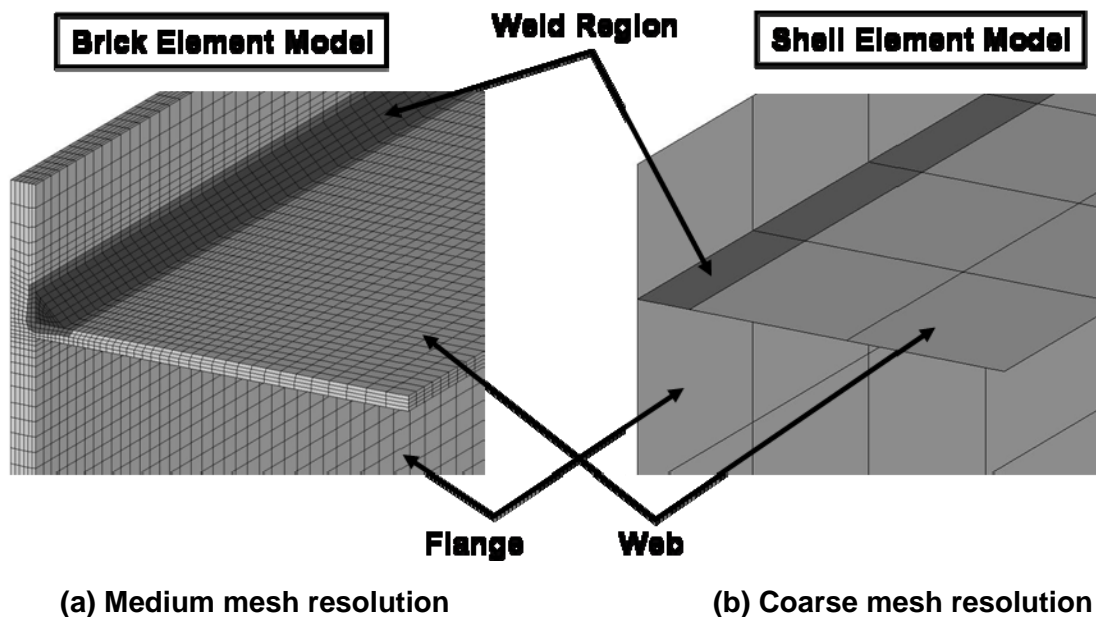
An average critical strain of approximately one-quarter of that in the corresponding base metal was selected for the 1 in. wide single shell element weld zone. This weld zone failure strain was 8 percent in the current example (55 ksi steel). The comparison of the resulting impact behavior for the brick and shell element models is shown in Figure 2–22. Both models had similar impact deformations, and the length of the weld failures were in good agreement. These analyses provided an upper bound value for the engineering fracture criteria in the weld region. Additional investigation of the weld failure and the effects of a more brittle fracture response were investigated in the subassembly analyses (Section 6.3.2). These subassembly impact analyses demonstrated that the weld zone fracture criterion had a negligible effect on the impact energy absorption and little significance on the impact damage.

Figure 2–20. Models developed for column weld fracture analysis.

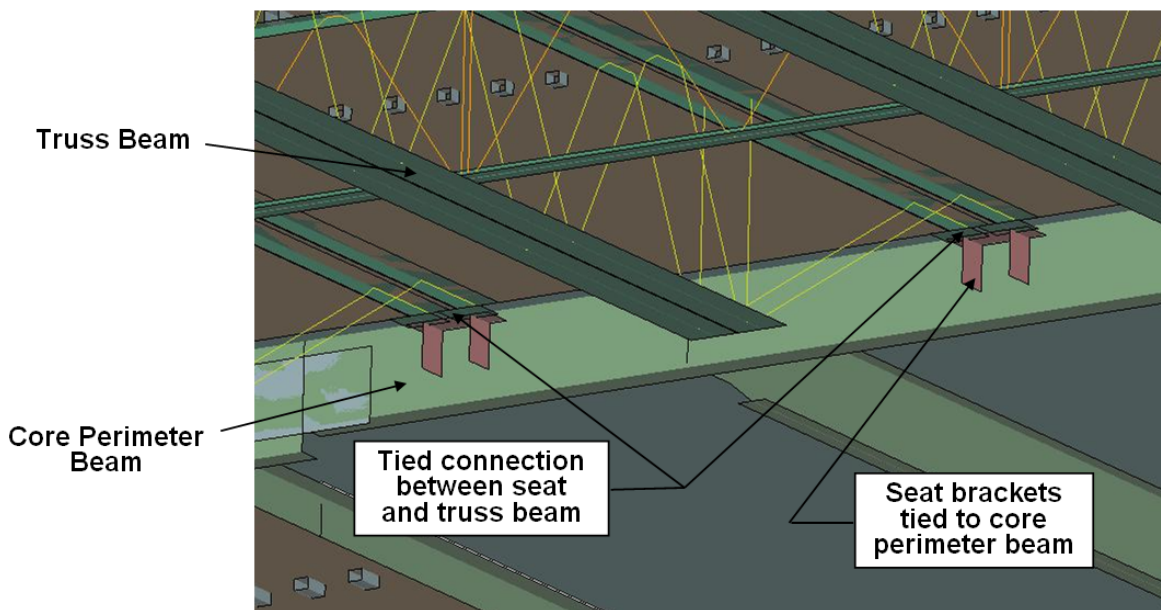
Figure 3–15 and Figure 3–16 show truss floor connection details at the exterior wall and core, respectively. The models for the truss seat connections were developed using shell elements and attached using the tied interface algorithm. The failure of the seats only occurs as a result of exceeding the ductility of the seat or truss structures.

Figure 3–16. Truss floor connection detail at core perimeter.

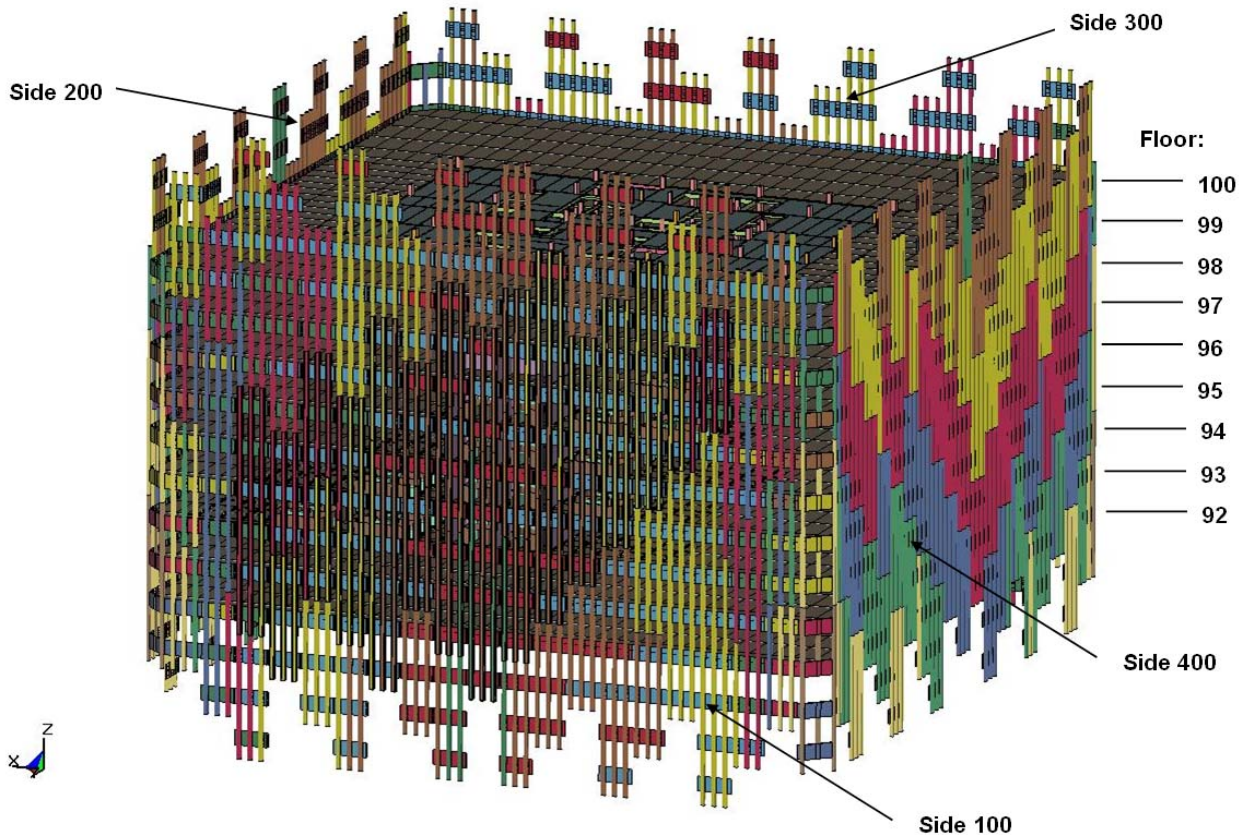
**Figure 3–21. Multi-floor global impact model of the WTC 1 tower.**

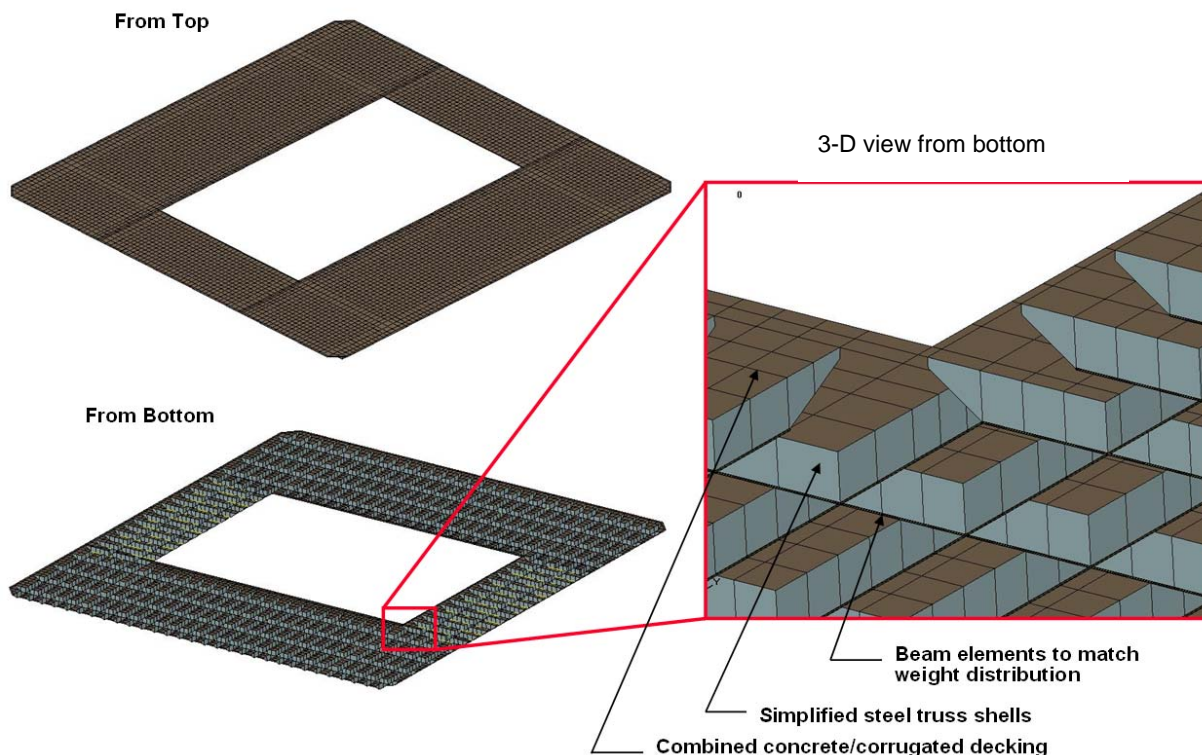
**Figure 3–25. Far field truss floor model in the WTC towers.**

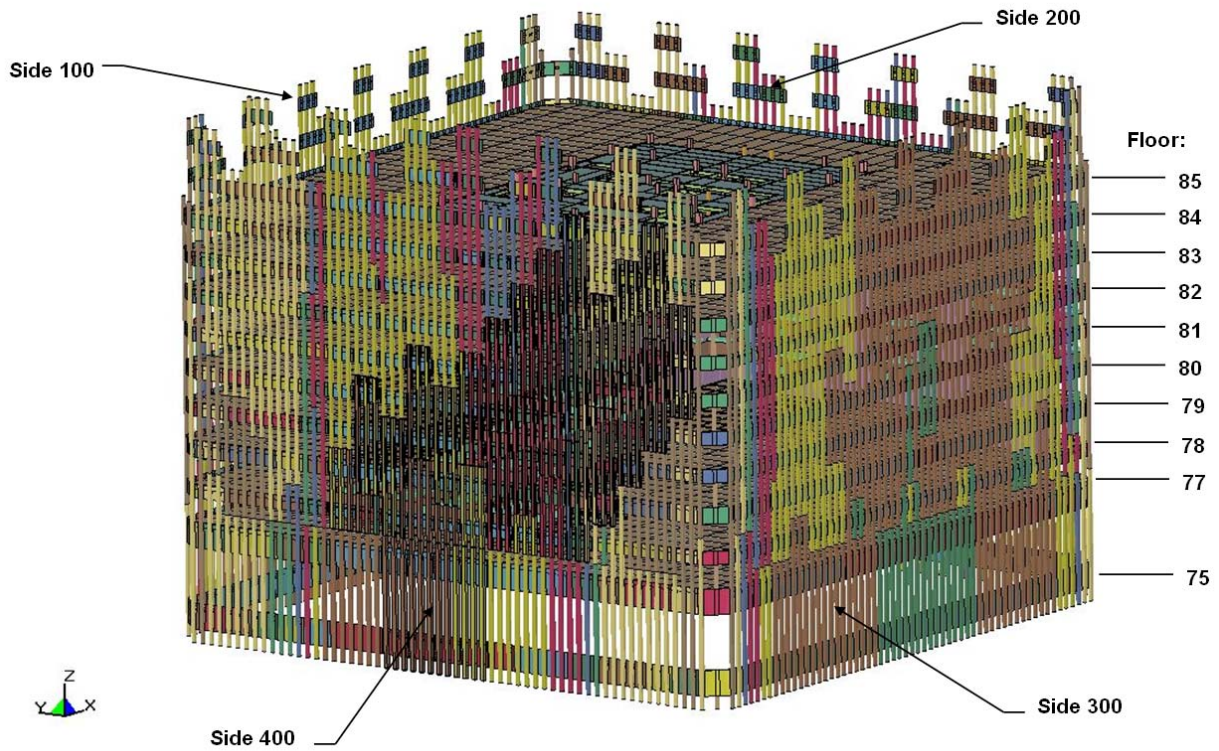
To summarize, the approach adapted for the development of the global impact models for towers WTC 1 and WTC 2 was similar. The structures were modeled primarily with shell elements with some beam elements in the detailed truss floor sections and bolted connections between the column ends in the impact zone of the exterior wall. Some brick elements were used at the exterior column butt plates in the detailed impact zone. A summary of the model size and element types for the global tower models is presented in Table 3–2.

Figure 3-26. Multi-floor global impact model of the WTC 2 tower.

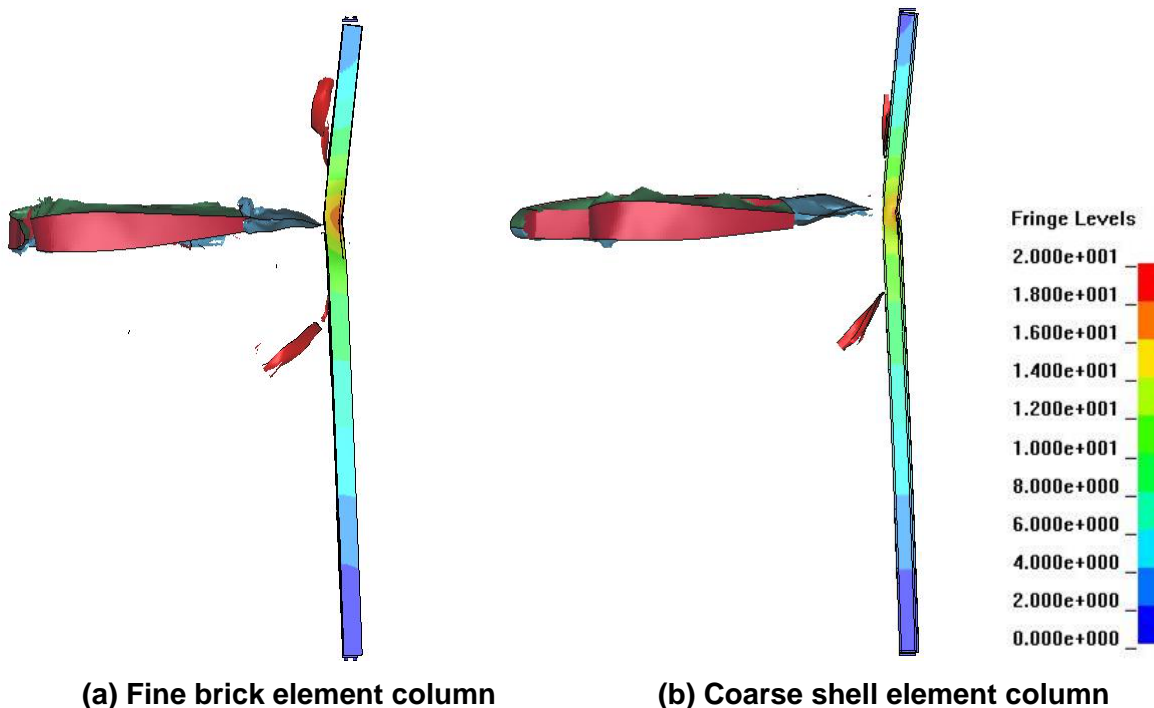
**Figure 5–4. Exterior column response comparison, showing contours of the displacement magnitude (inches).**

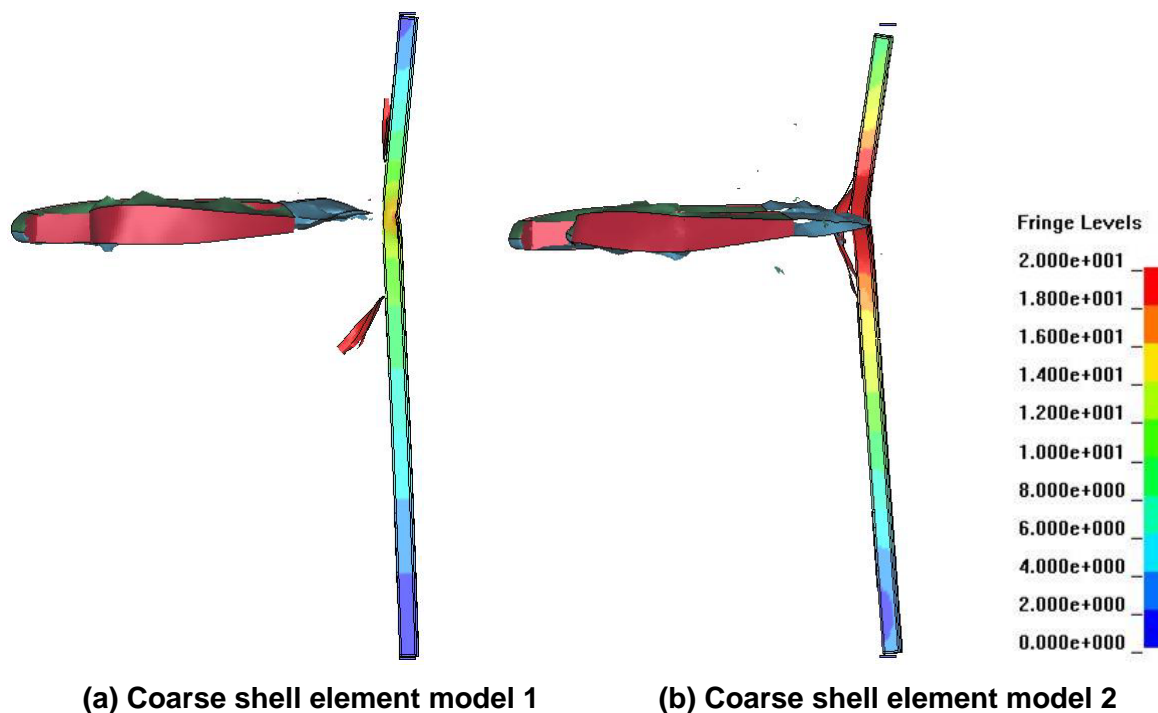
**Figure 5–5. Exterior column response comparison, showing contours of the displacement magnitude (inches).**

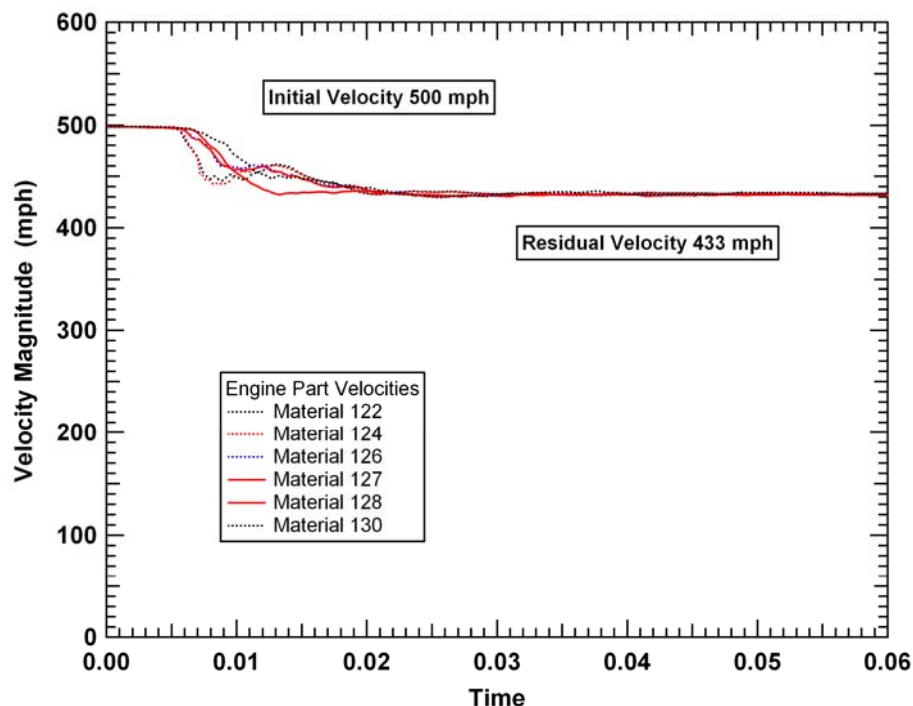
**Figure 5–16. Engine velocity history for the exterior wall impact.**

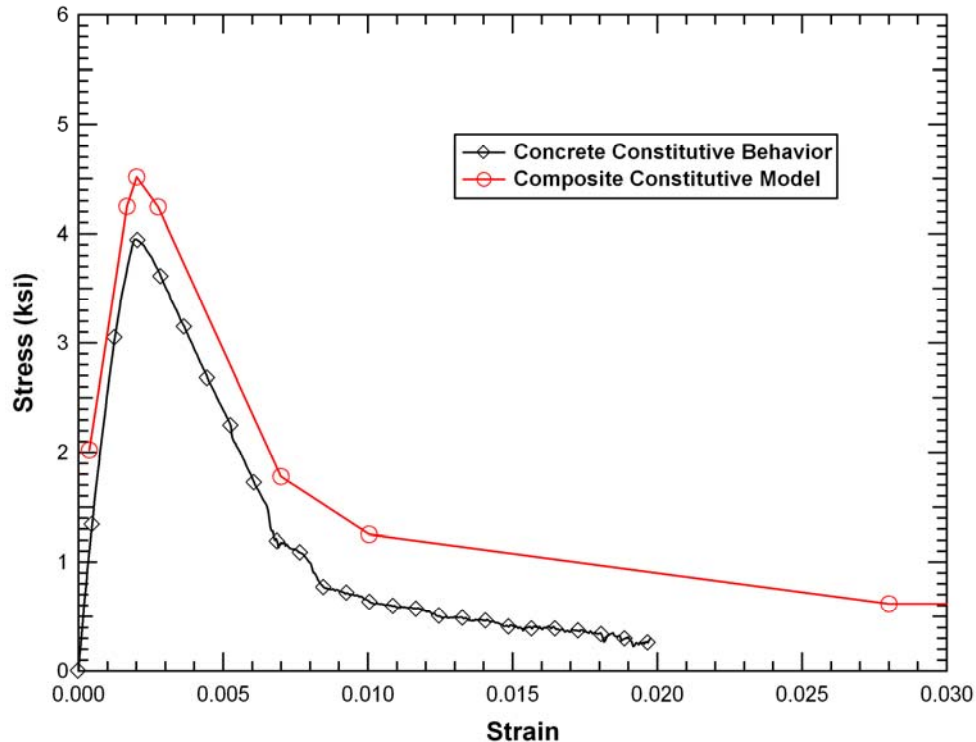
**Figure 5–24. Constitutive behavior for the combined concrete and metal decking.**

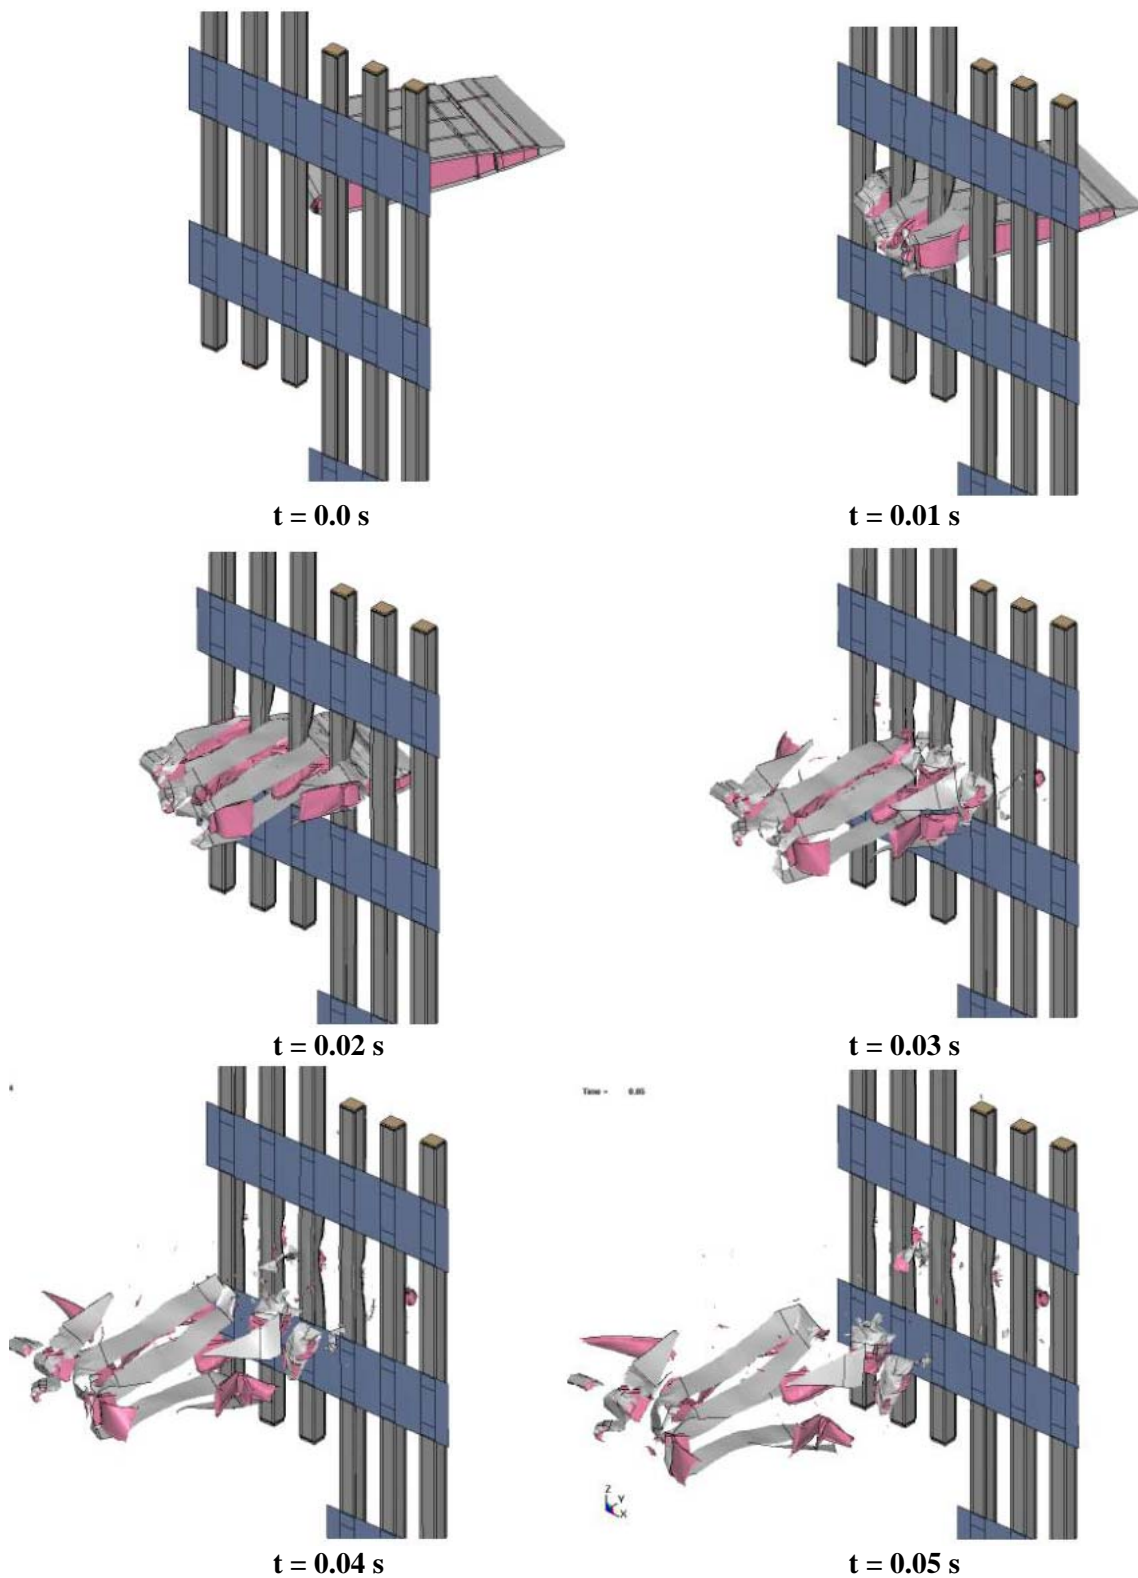
**Figure 5–31. Calculated impact of a fine-mesh empty wing section with two exterior panels at 442 mph.**

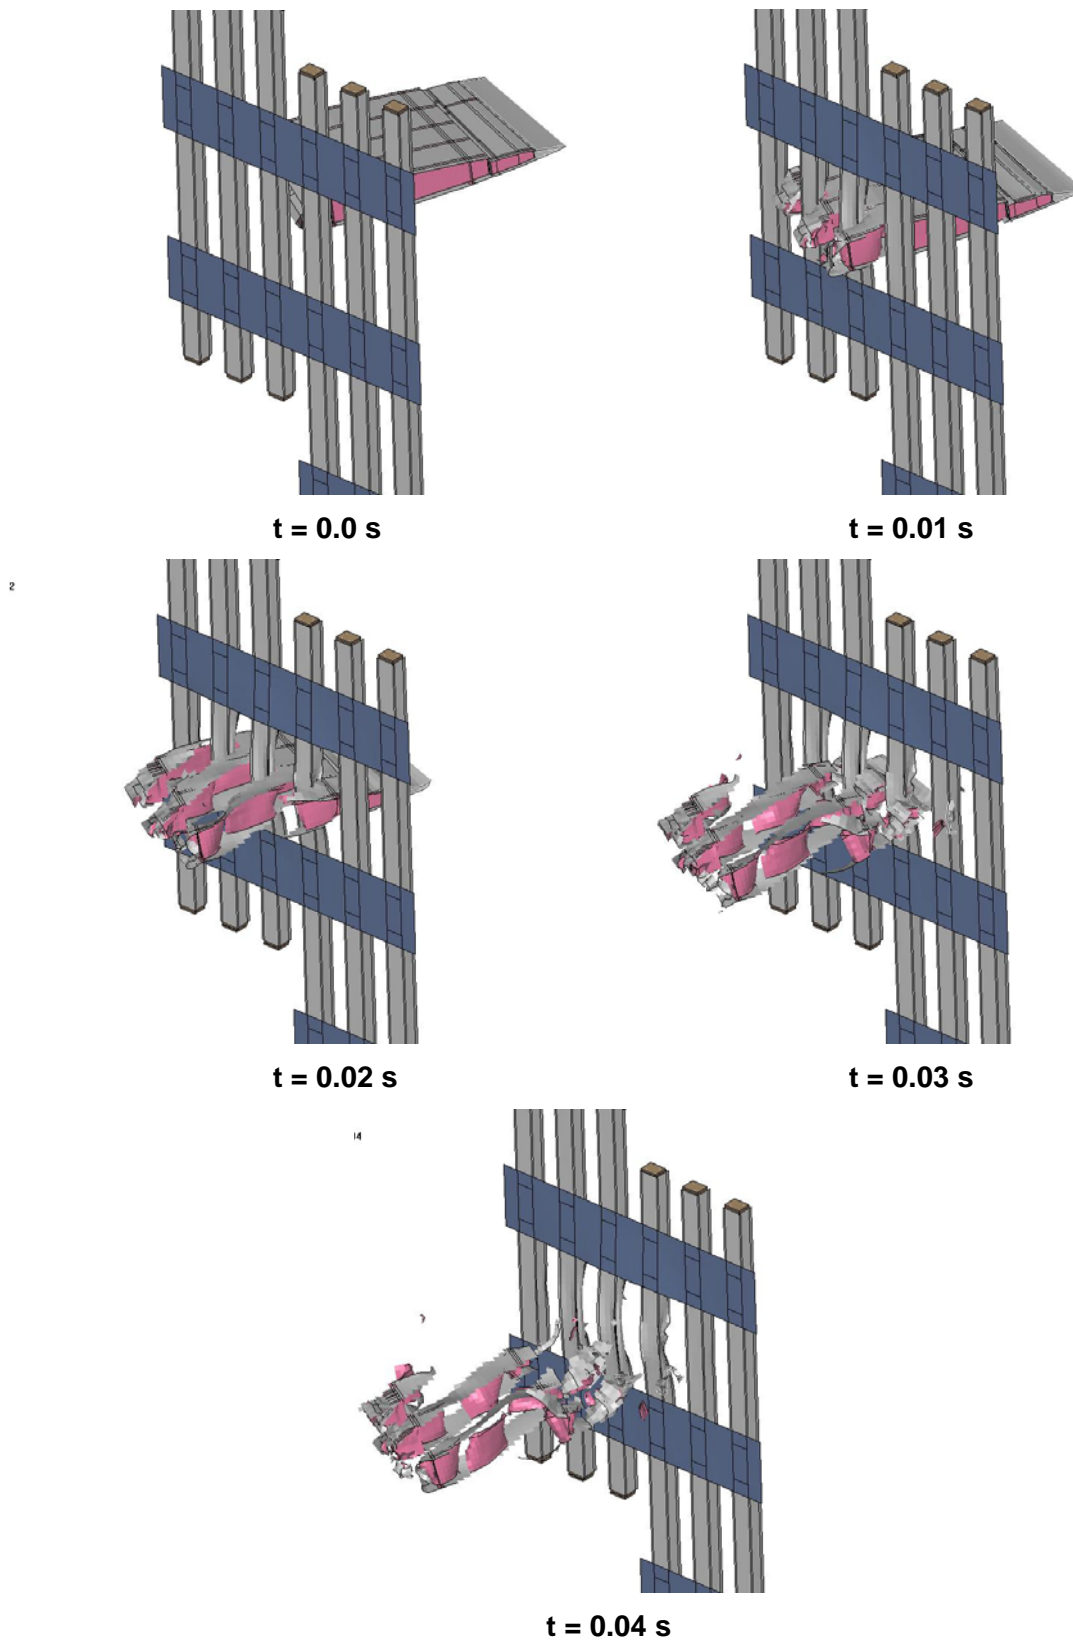
**Figure 5–37. Calculated impact of a coarse-mesh empty wing section with two exterior panels at 442 mph.**

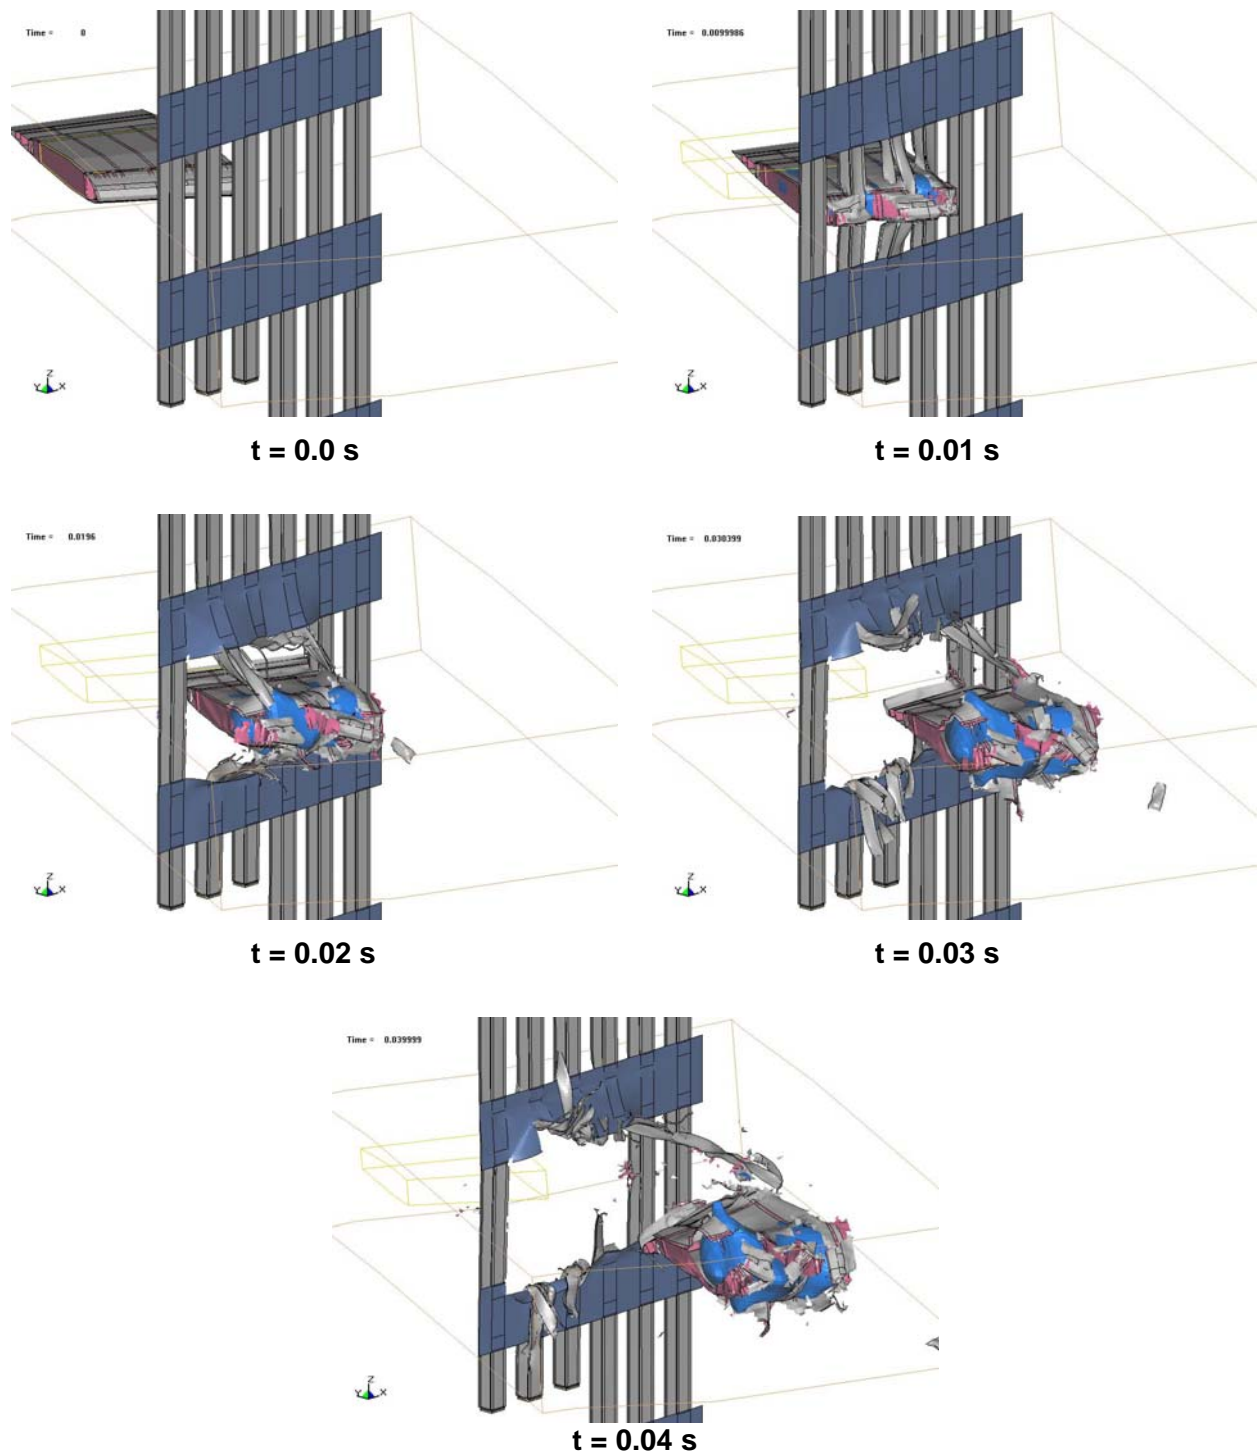
**Figure 5–42. Calculated impact of a coarse mesh wing section laden with fuel modeled using ALE elements.**

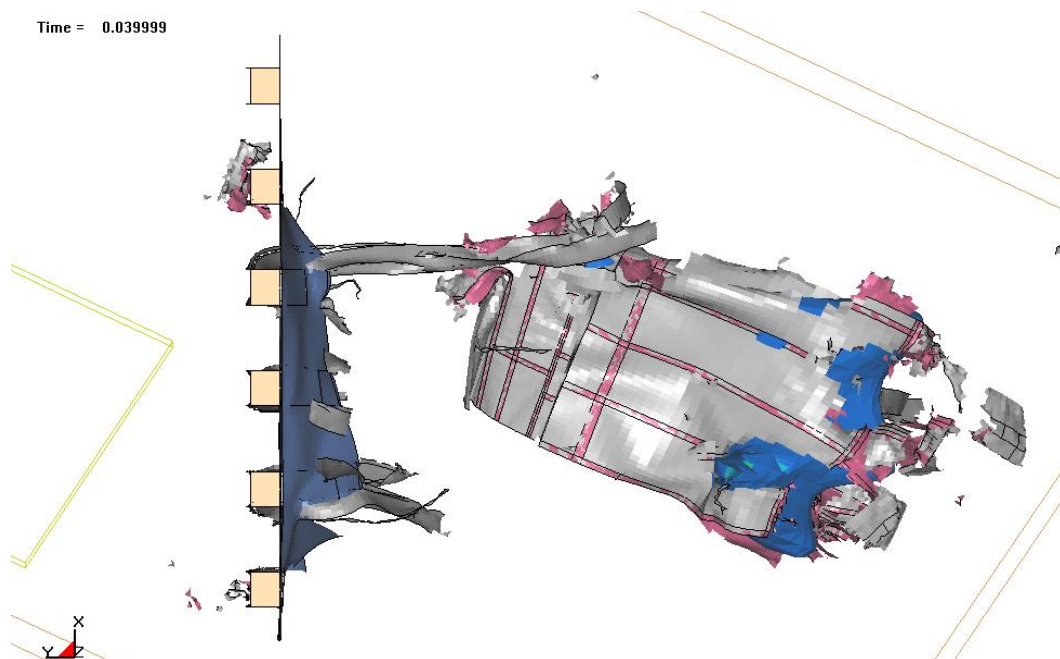
**Figure 5-46. ALE analysis of structural damage and fuel dispersion at 0.04s (top view).**

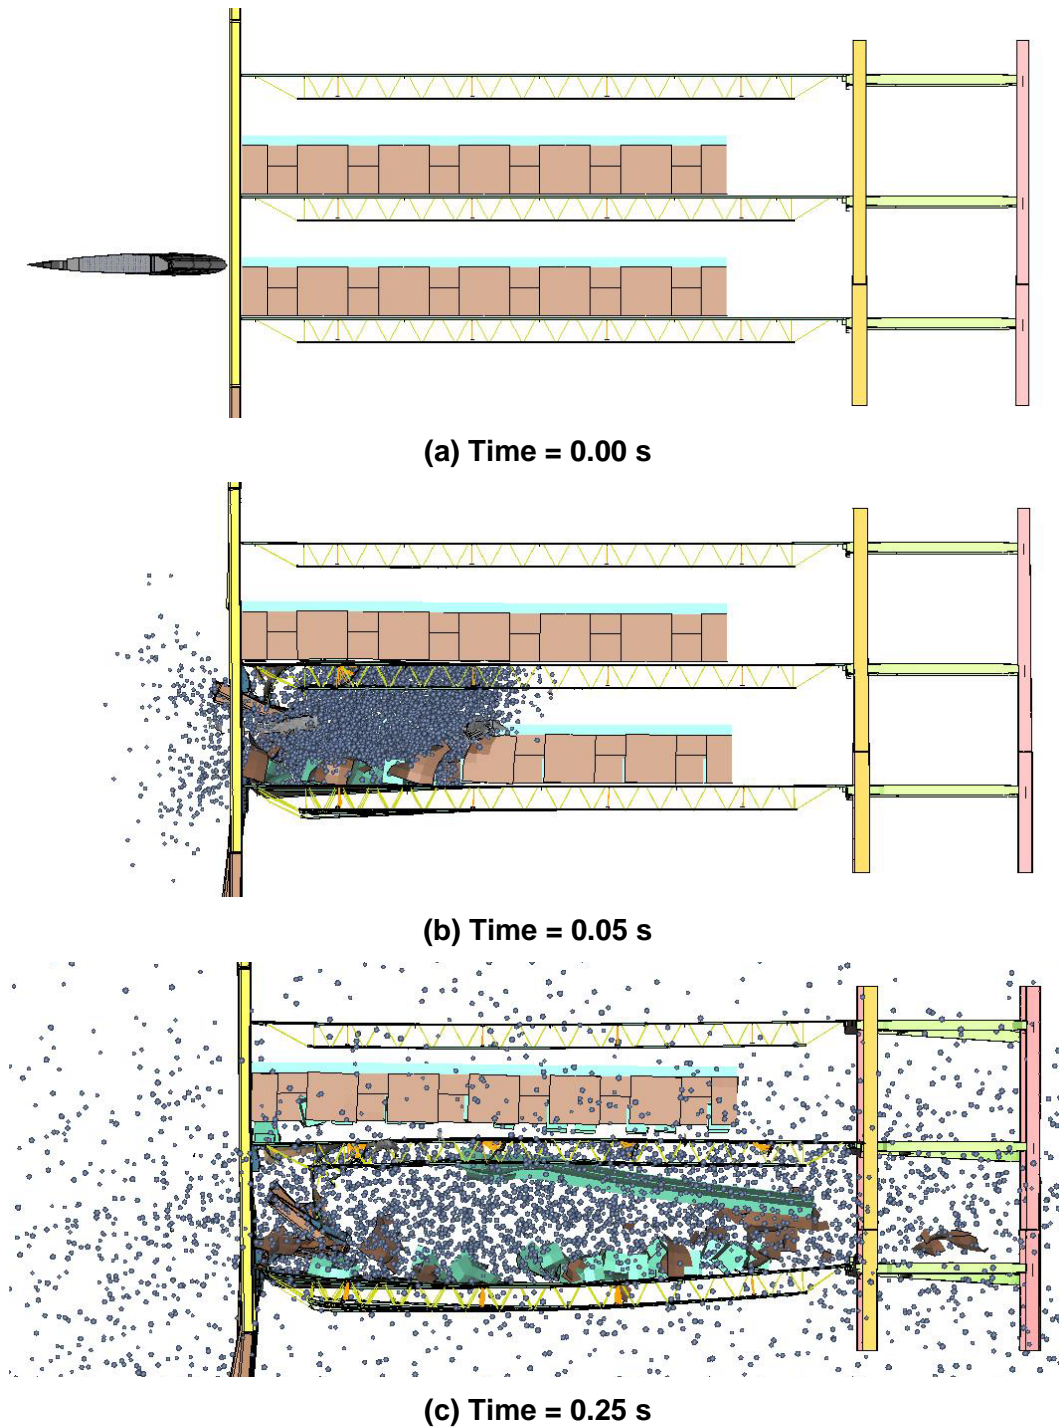
**Figure 6–14. Baseline wing section impact and break up behavior (side view).**
