**NIST NCSTAR 1-2B**

**Federal Building and Fire Safety Investigation of the  
World Trade Center Disaster**

**Analysis of Aircraft Impacts into the  
World Trade Center Towers**

September 2005

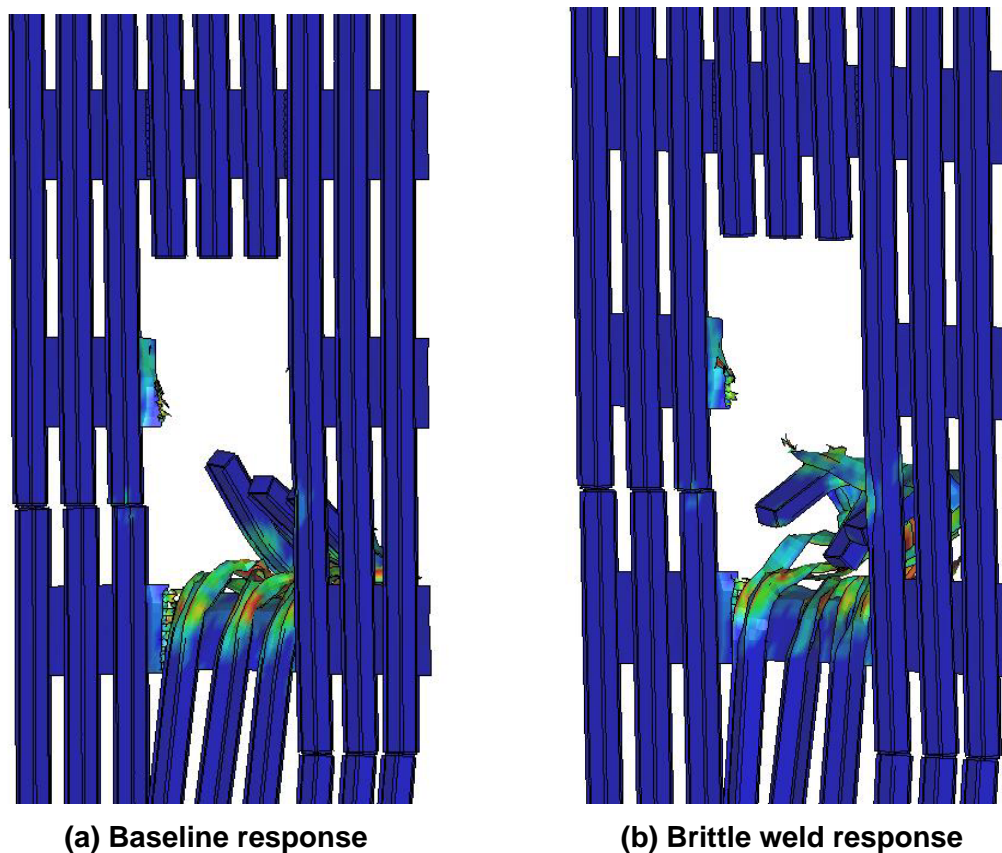
Figure 6–16. Exterior wall damage for the wing section impact analyses.

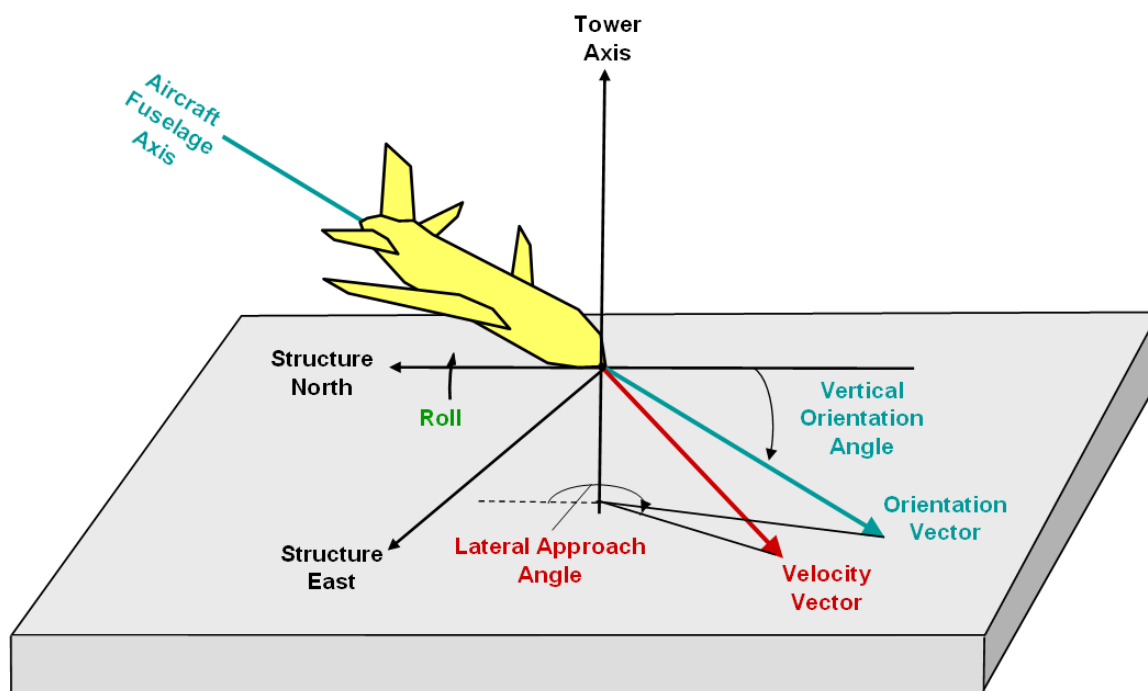
Figure 7–1. Definitions of the aircraft impact parameters.

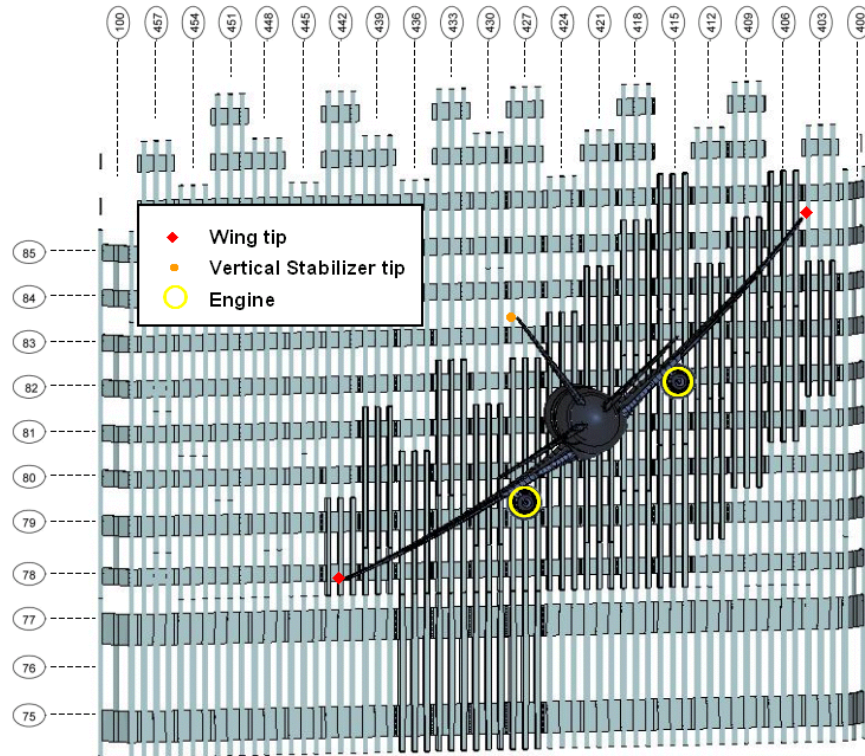
Figure 7-11. An orientation and trajectory of UAL 175 that matches the impact pattern (vertical approach angle =  $6^\circ$ , lateral approach angle =  $13^\circ$ ).

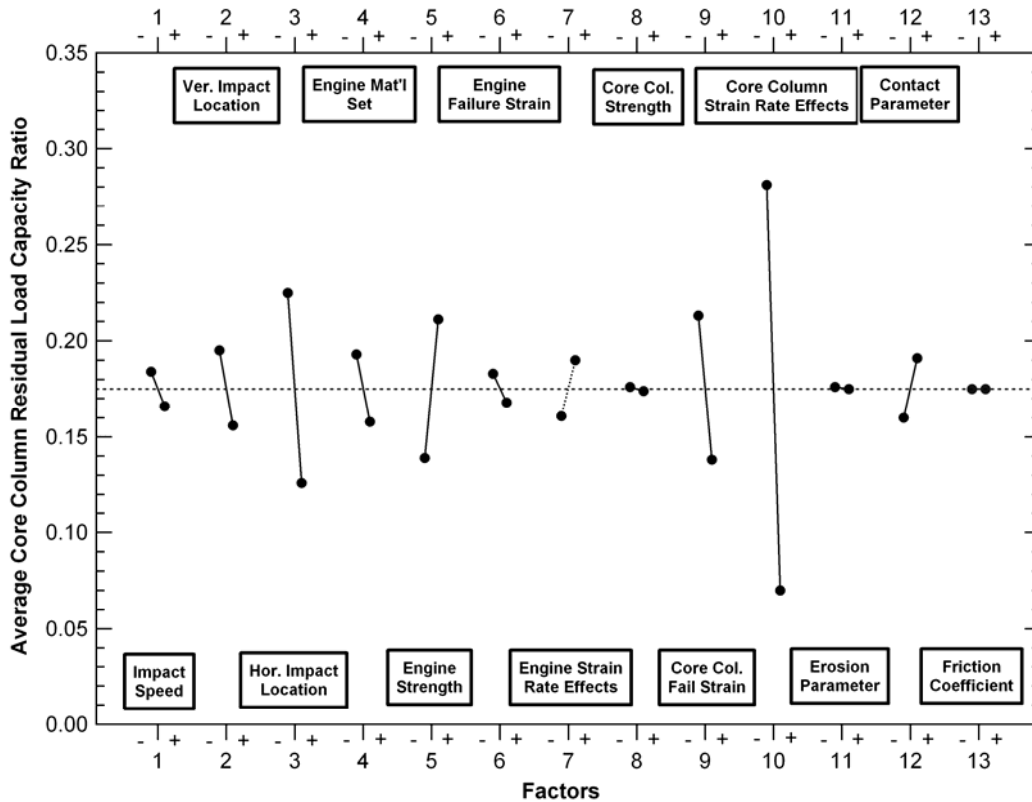
**Figure 8-3. Main effects plot for the engine - core column impact analyses.**

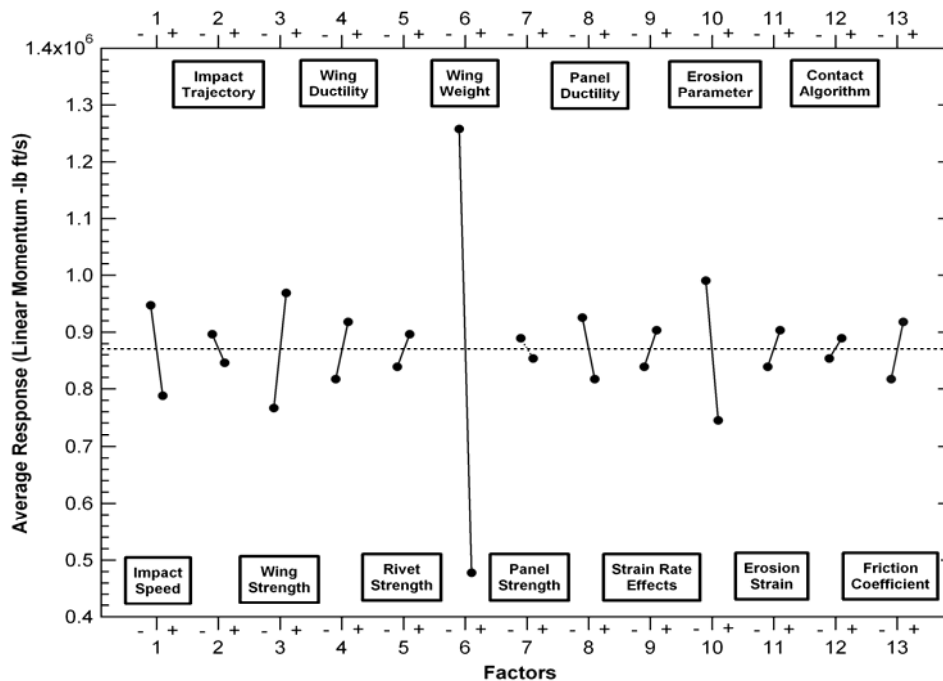
**Figure 8–6. Main effects plot for the wing-panel impact analyses.**
